## **DISTRICT OF NORTH VANCOUVER**

# **1576 AND 1582 MERLYNN CRESCENT LANDSLIDE RISK REASSESSMENT**

PROJECT NO.: 0404081

DATE: October 24, 2017

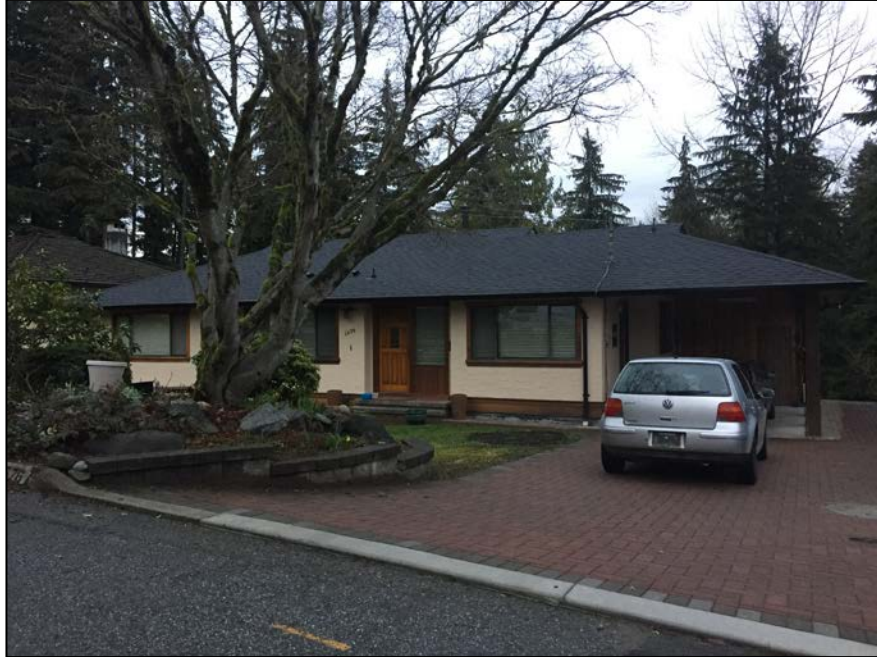
The single-family home of 1576 Merlynn Crescent is situated approximately 4.5 m upslope from the escarpment crest (Photograph 1, Appendix C). A concrete retaining wall with an overall height of 2.4 m was recently constructed along the crest of the slope (Photographs 2 and 3, Appendix C). Slope angles downslope of the retaining wall are approximately 40°. No deterioration of the escarpment slope conditions below the retaining wall was noted since the 2013 field inspections.

**Photograph 1. 1576 Merlynn Crescent – Front view of house from street.**

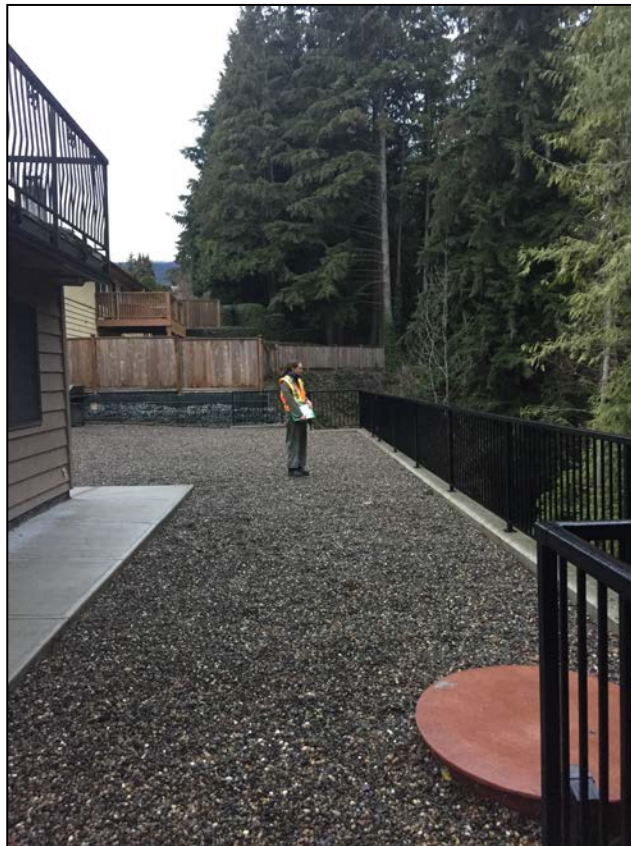
**Photograph 2. 1576 Merlynn Crescent – Looking north across backyard with fence at the top of concrete retaining wall.**

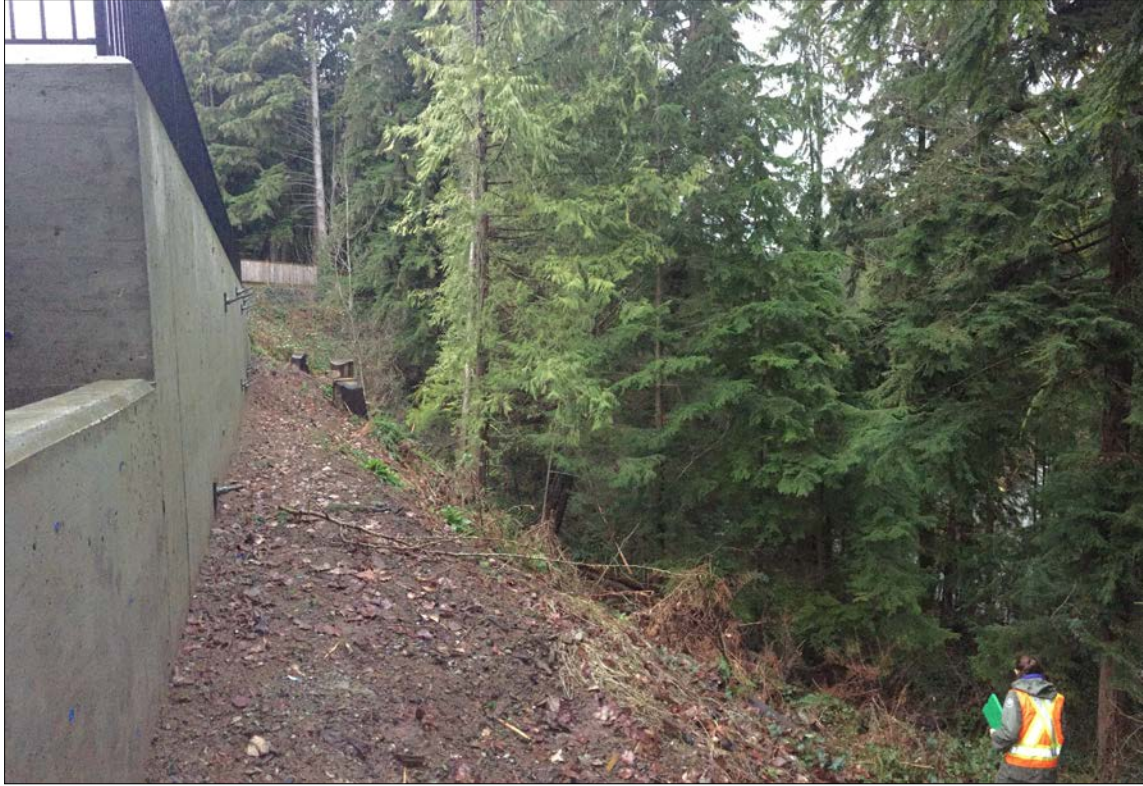
**OBSERVATIONS:** Area below retaining wall (approximately 15 m downslope from wall) has been recently cleared, including 5 large (~1 m) in diameter tree stumps near the crest at the north end of the property. Woody debris and concrete debris found on the slope below the retaining structure.

**Photograph 3. 1576 Merlynn Crescent – Looking northeast at the escarpment slope below the concrete retaining wall.**

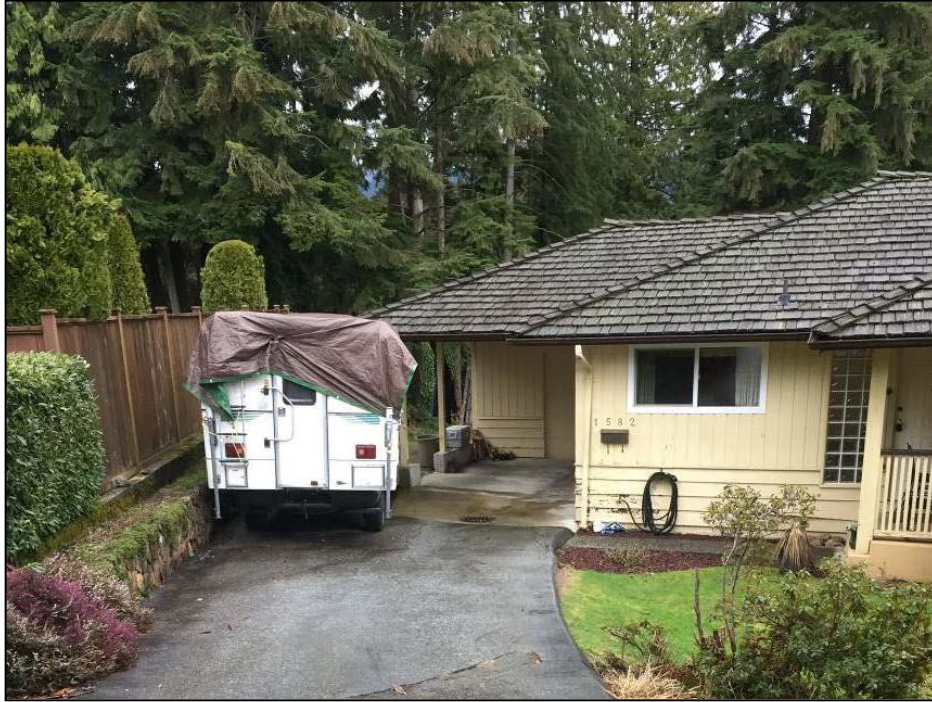
**Photograph 4. 1582 Merlynn Crescent – Front view of house from street.**

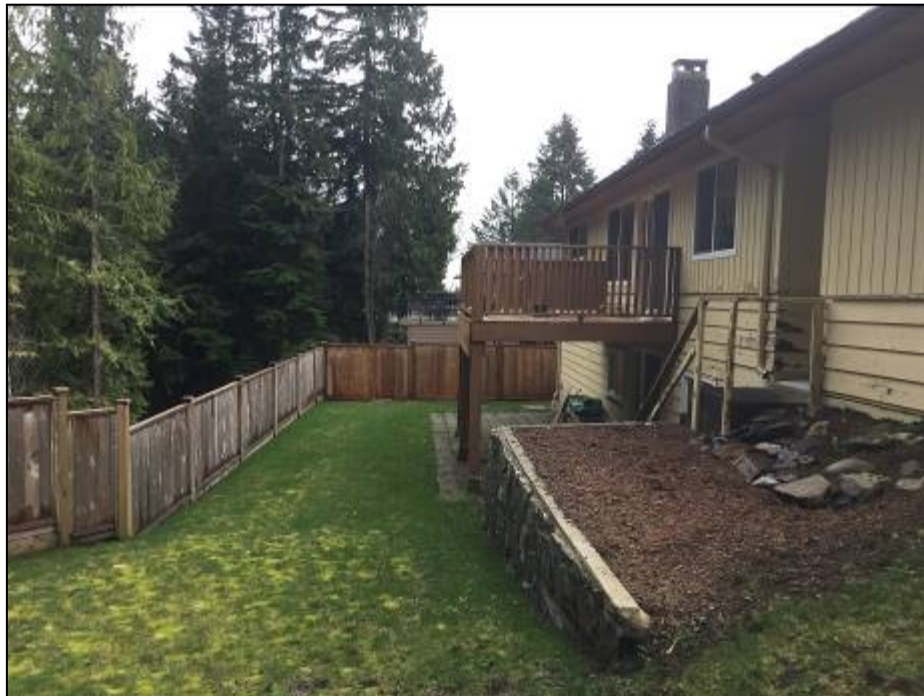
**Photograph 5. 1582 Merlynn Crescent – Looking south at backyard. Wood fence is located on top of the retaining wall at the escarpment crest.**

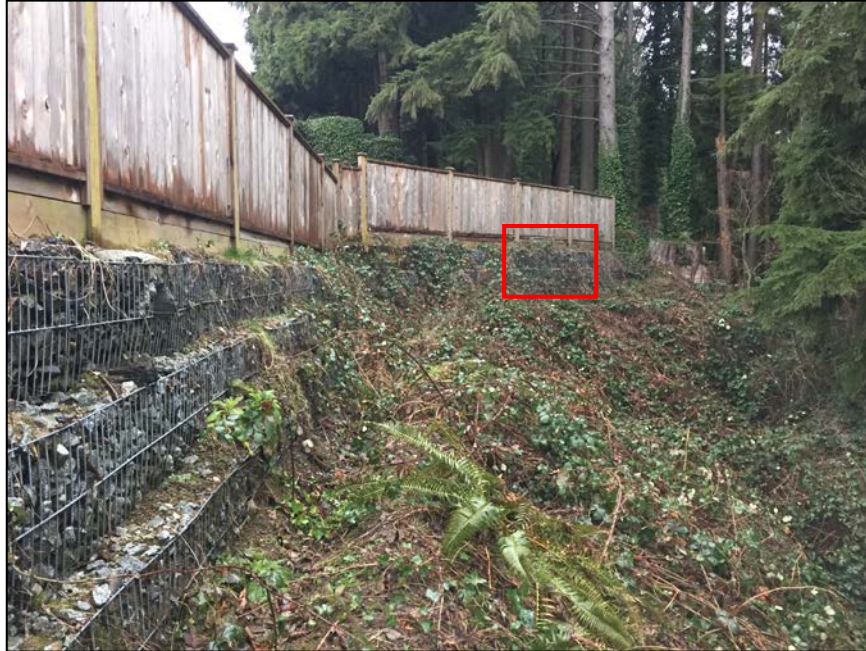
**Photograph 6. 1582 Merlynn Crescent – Looking north at slope crest and GRS retaining wall. Red square showing location of close-up in Photograph 7.**

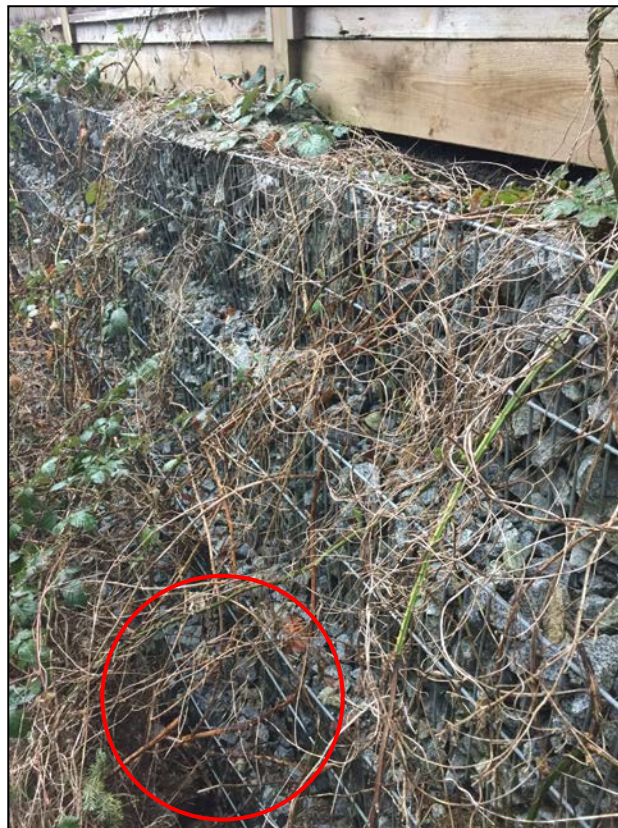
An approximately 10 cm 'bulge' was observed on the northwest end of the retaining wall in the fourth row (from the top). Based on the lack of additional wall deformation indicators and the fact that the bulge was isolated to a single MSE wall cage, the bulge was interpreted to be related to damage or over-compaction of the wall materials adjacent to the cage face.

**Photograph 7. 1582 Merlynn Crescent – Slight bulge (~ 10 cm) in lower row cage (red circle). This is interpreted to be the result of construction damage.**

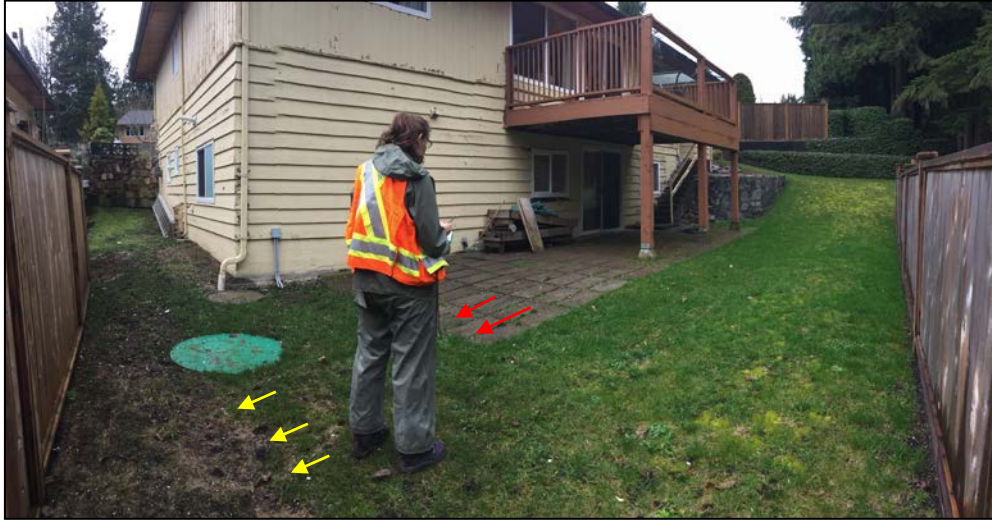
Settlement was observed in the backyard of 1582 Merlynn Crescent, where patio stones at the south side of the patio had settled approximately 15 to 20 cm (vertical distance) (Photograph 8). This settlement is interpreted to predate the construction of the retaining wall. Settlement was also observed on the south side of the property along a newly constructed fence. Settlement in this area was interpreted to be related to the removal of shrubs previously located in this area.

**Photograph 8. 1582 Merlynn Crescent – Arrows show settlement of lawn near fence (yellow) and in patio stones (red).**
