District of North Vancouver

Debris Flow - Debris Flood Study and Risk Mitigation Alternatives for Deep Cove Creeks

**Final Report
December 2003**

KWL File No. 31.290

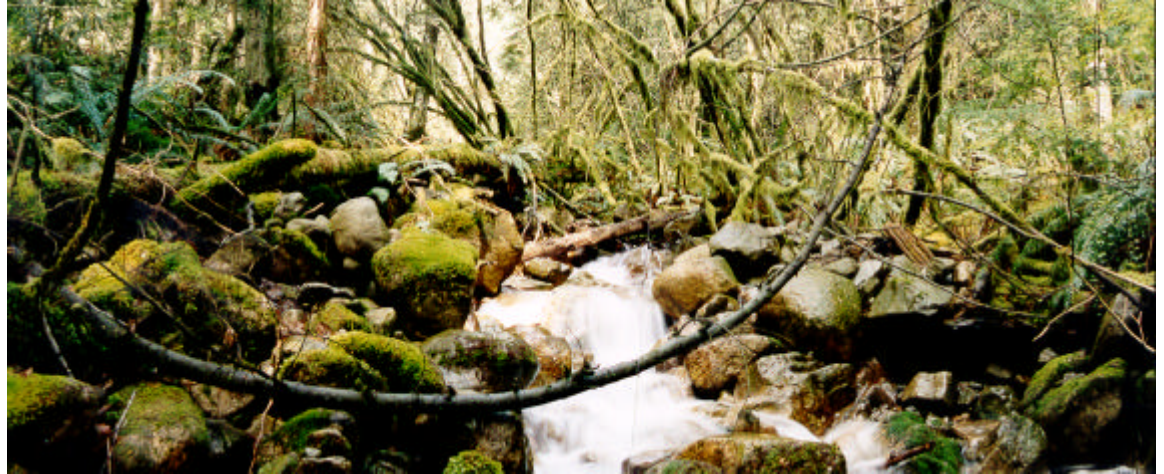
Photo P-1

Typical view of Panorama Creek between Indian River Drive and Mount Seymour Road. March 2001.

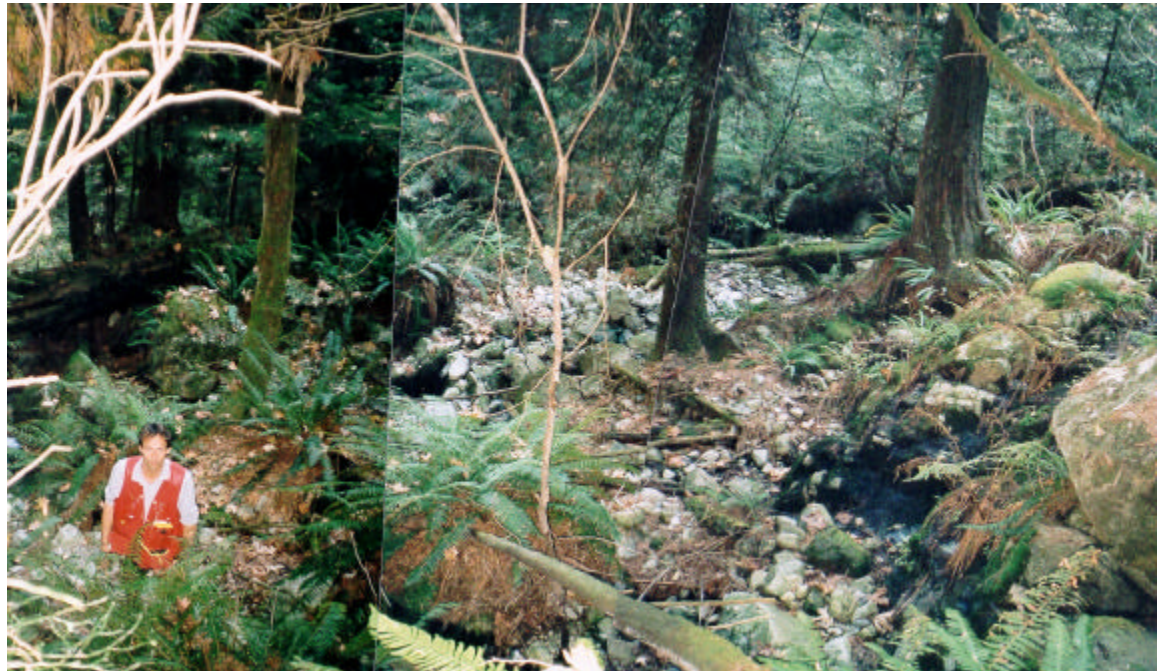
Photo P-2

Panorama Creek approximately 350 m upstream of Panorama Drive. October 2001.

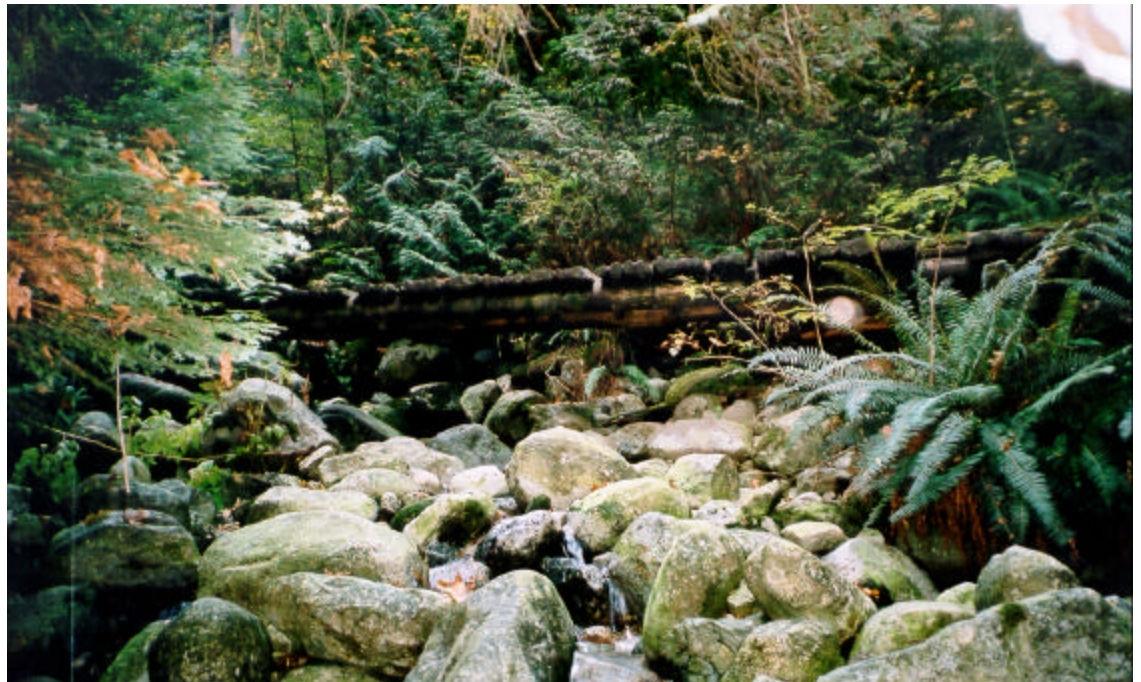
Photo P-3
Baden-Powell trail crossing of Panorama Creek. October 2001.

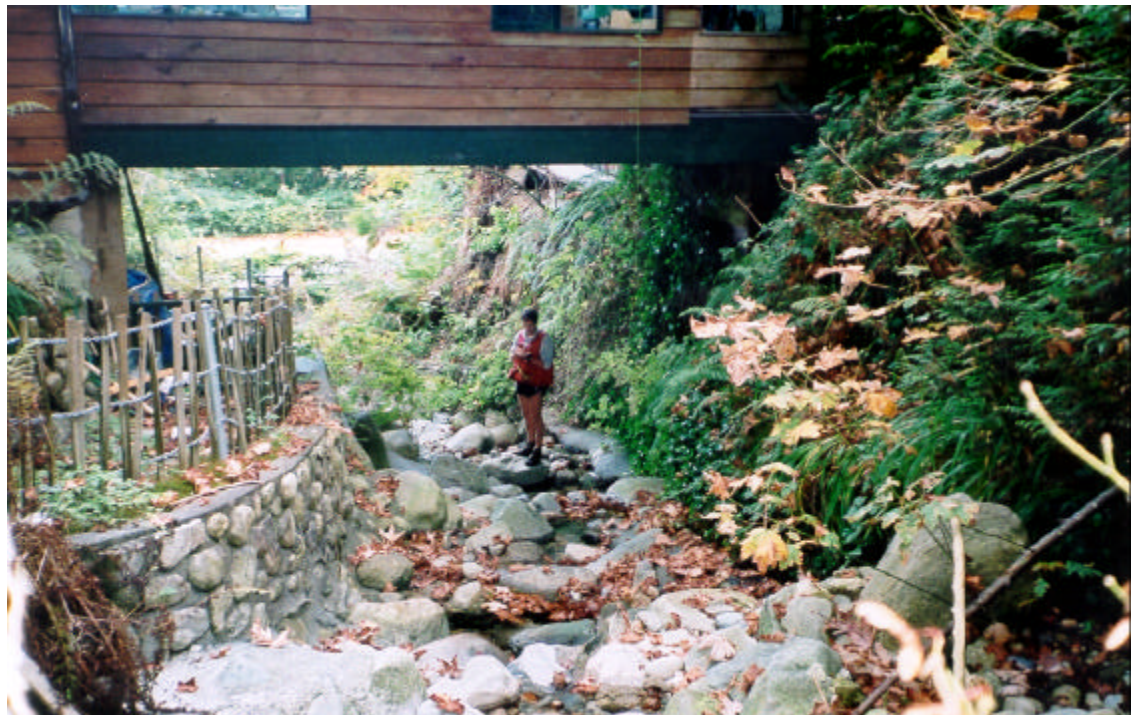
Photo P-4
House addition constructed across Panorama Creek above Panorama Drive. October 2001.

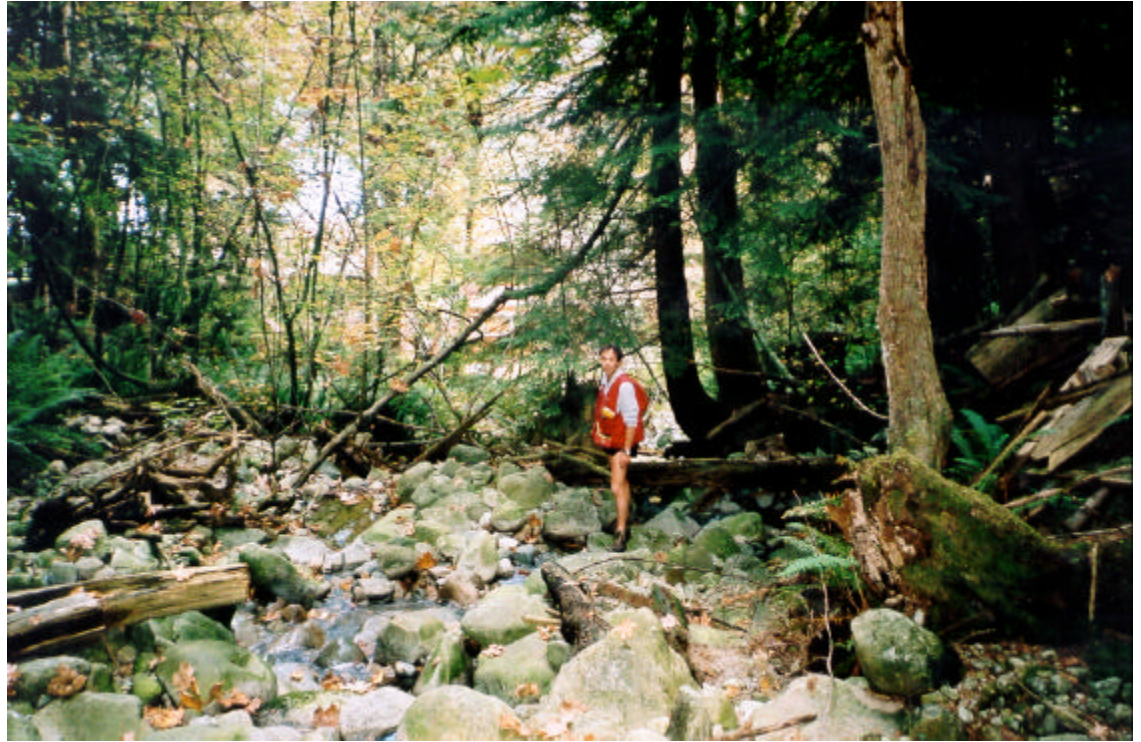
Photo P-5

Approximately 20 m wide deposition zone located immediately upslope of Panorama Drive development. October 2001.

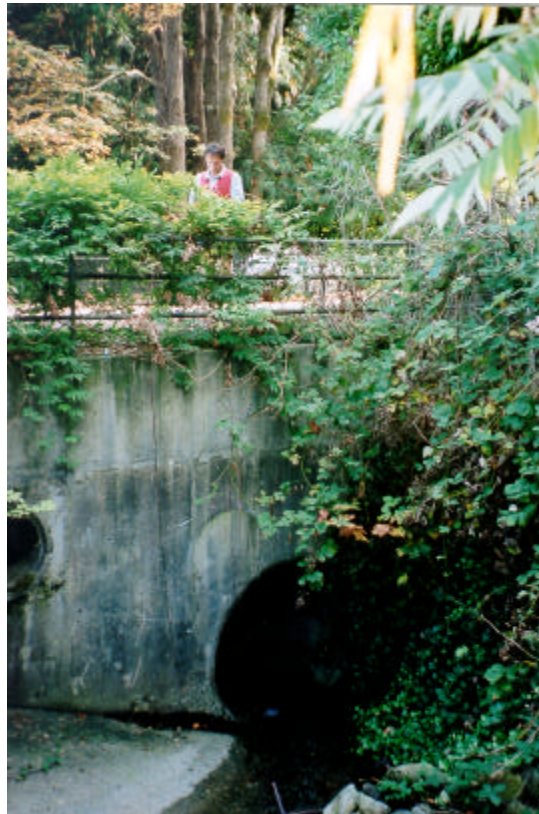
Photo P-6

Culvert inlet for Panorama Creek at Panorama Drive. A 600 mm overflow culvert is visible to the left of the main 1250 mm culvert. October 2001.

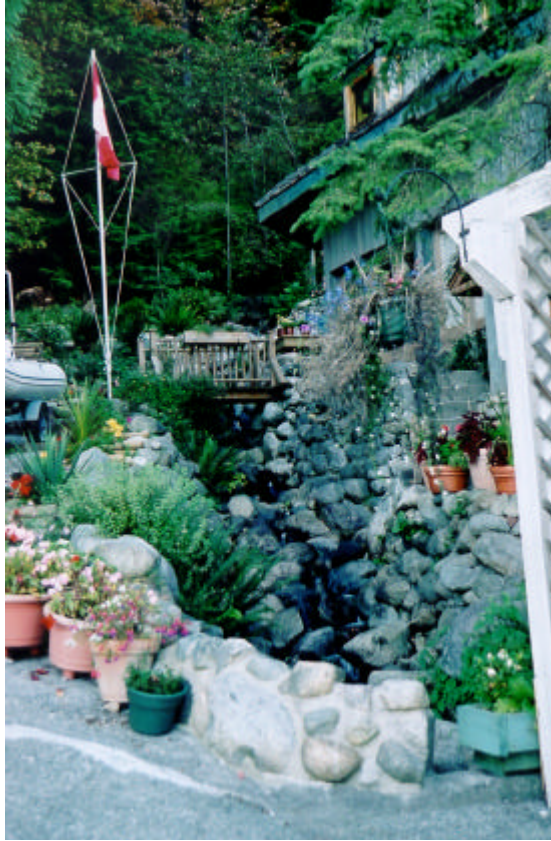
Photo M-3

Channelized section of Mathews Creek flowing adjacent to house upslope of Panorama Drive. October 2001.

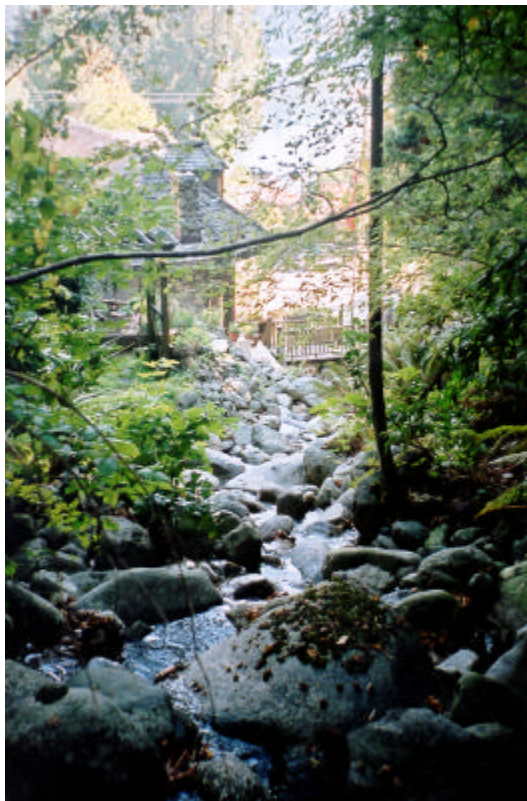
Photo M-4

Poorly confined section of Mathews Creek immediately upslope of residential property located above Panorama Drive. October 2001.

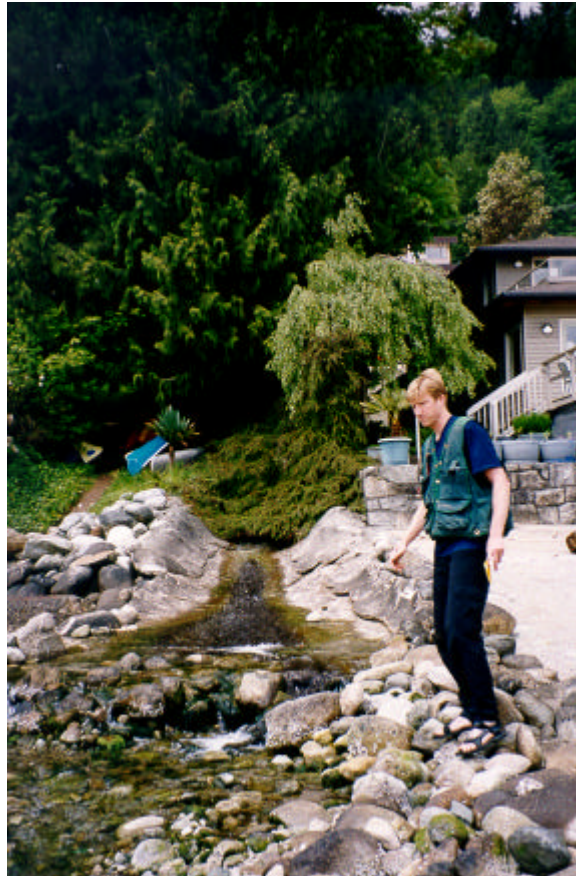
Photo M-5

View of Mathews Creek at creek mouth. Below Panorama Drive the creek flows in a concrete channel. May 2002.

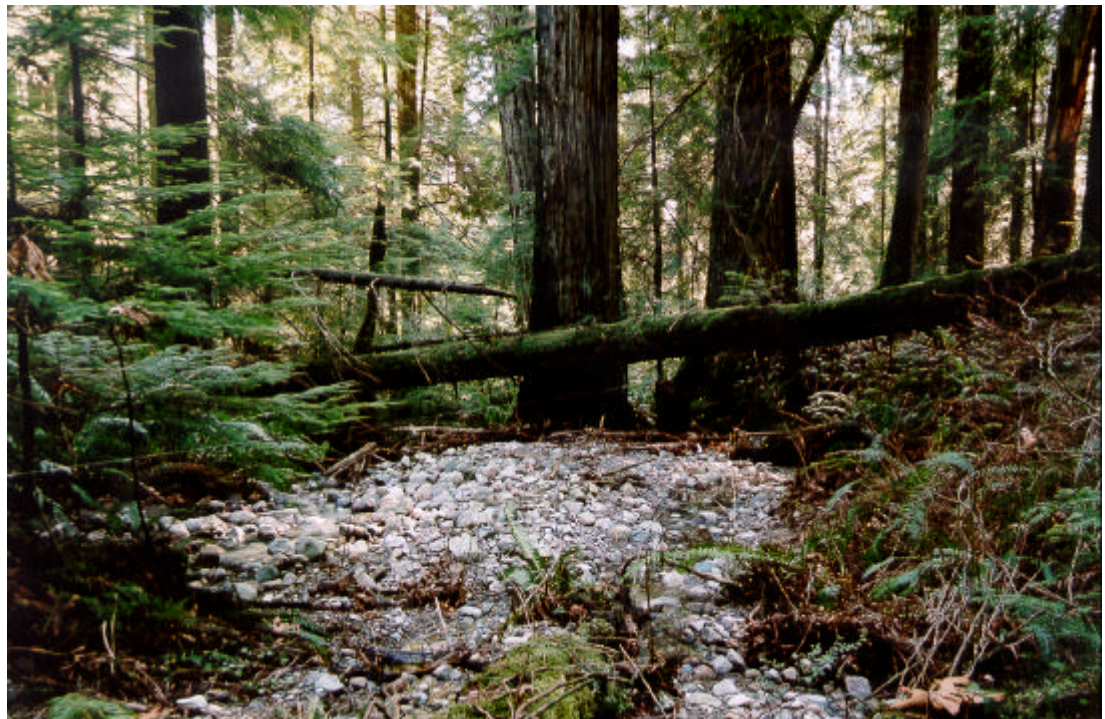
Photo G-2

Active sediment transport in Gavles Creek about 100 m downstream of Indian River Drive. March 2001.

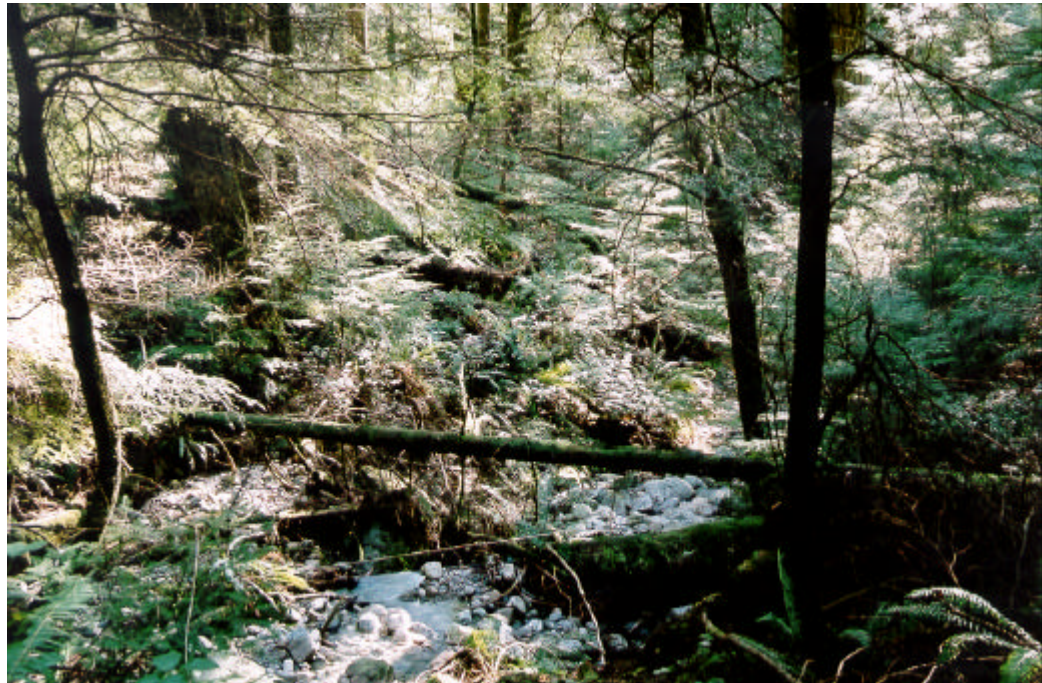
Photo G-3

Gavles Creek about 200 m downstream of Indian River Drive. Sediment transport is significantly less than upstream reaches. March 2001.

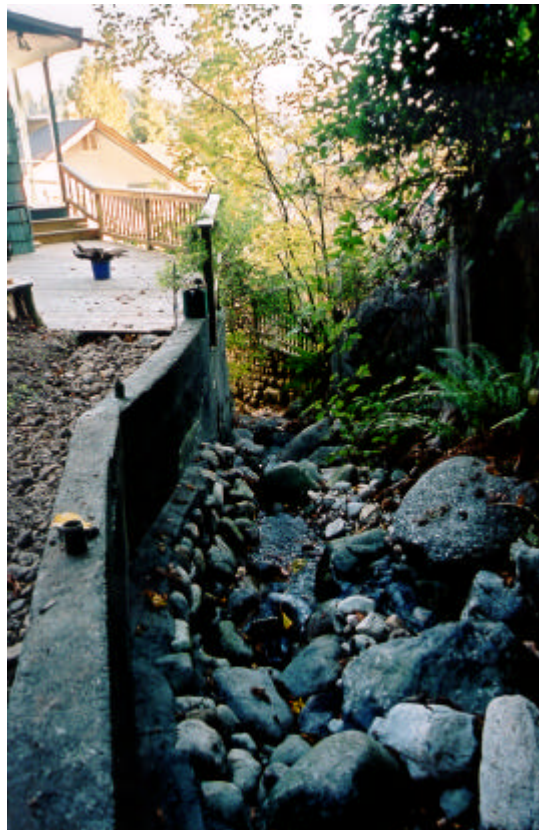
Photo G-4

Gavles Creek flowing adjacent to residential property upstream of Panorama Drive. October 2001.

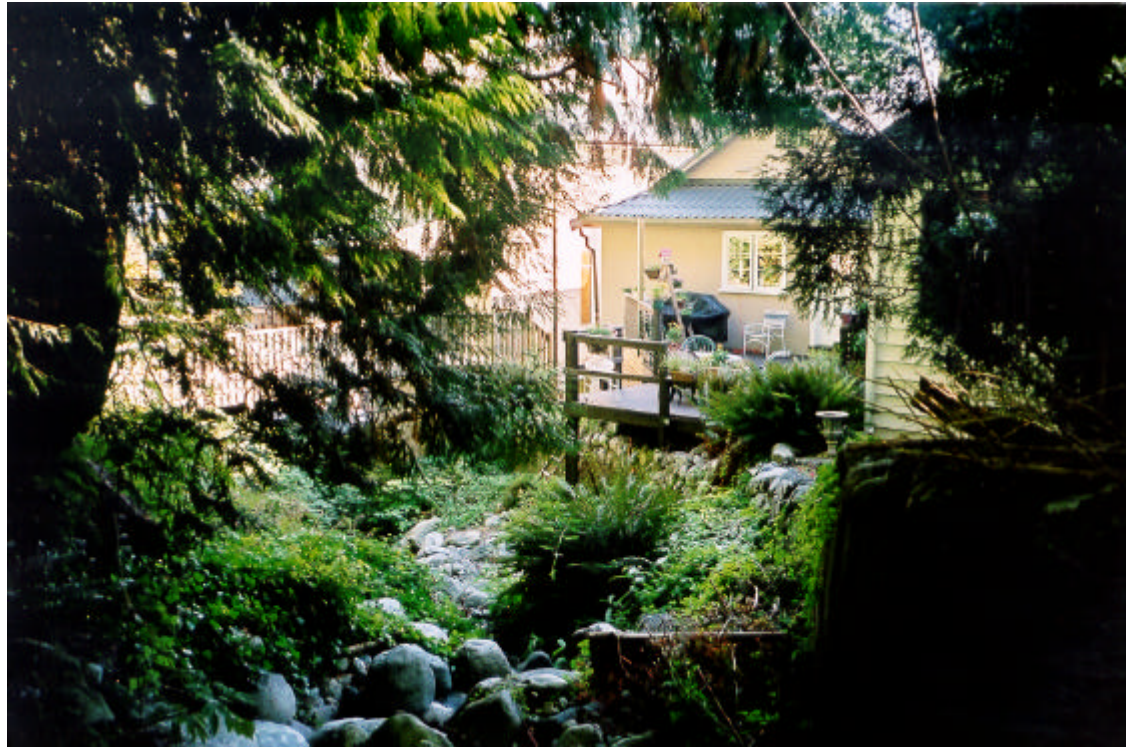
Photo C-3

Cove Creek flowing adjacent to residential properties upstream of Panorama Drive. October 2001.

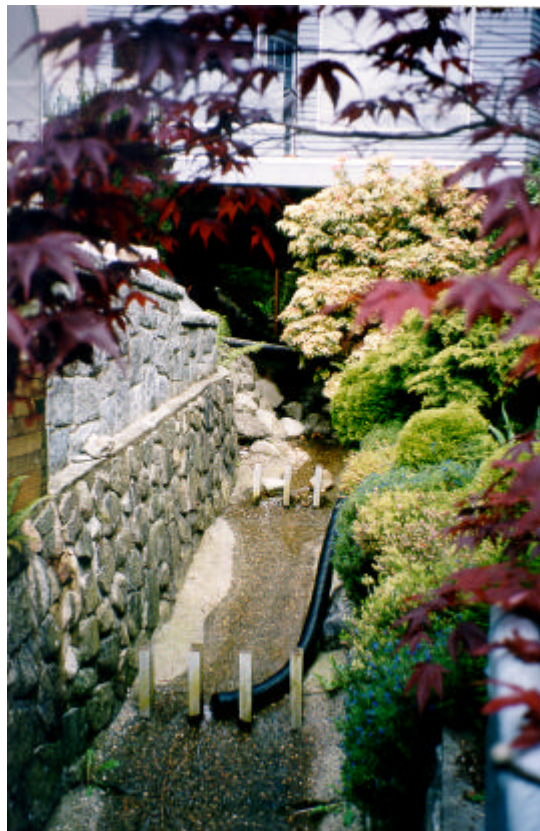
Photo C-4

Cove Creek flowing under residential property immediately upstream of Panorama Drive. May 2002.

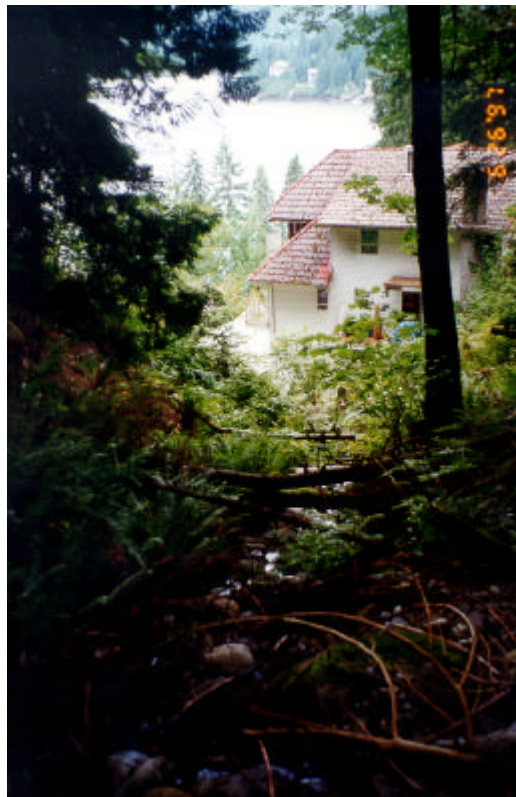
Cleopatra Creek: At the fan apex, Cleopatra Creek flows into the back yard of house #2755 (Photo CL-2). While the main part of the house is not likely to be damaged by the design debris flood, the creek does flow to the immediate east of the house. Here the creek flows under a workshop and through a 1,000 mm culvert, above which a patio has been constructed (Photo CL-3). Both structures could be directly impacted by a debris flood. Where the channel flows under the workshop, a channel avulsion could also occur during a 200-year return period flood. Unlike the other creeks along Panorama Drive, the culvert for Cleopatra Creek is poorly constructed, with a vertical drop to the inlet and a lack of wingwalls. However, the culvert does have sufficient capacity for the 200-year return period flood in the absence of blockages.

Photo CL-2
Downstream view of Cleopatra
Creek. The house in the
background is located upslope
of Panorama Drive. June 1997.

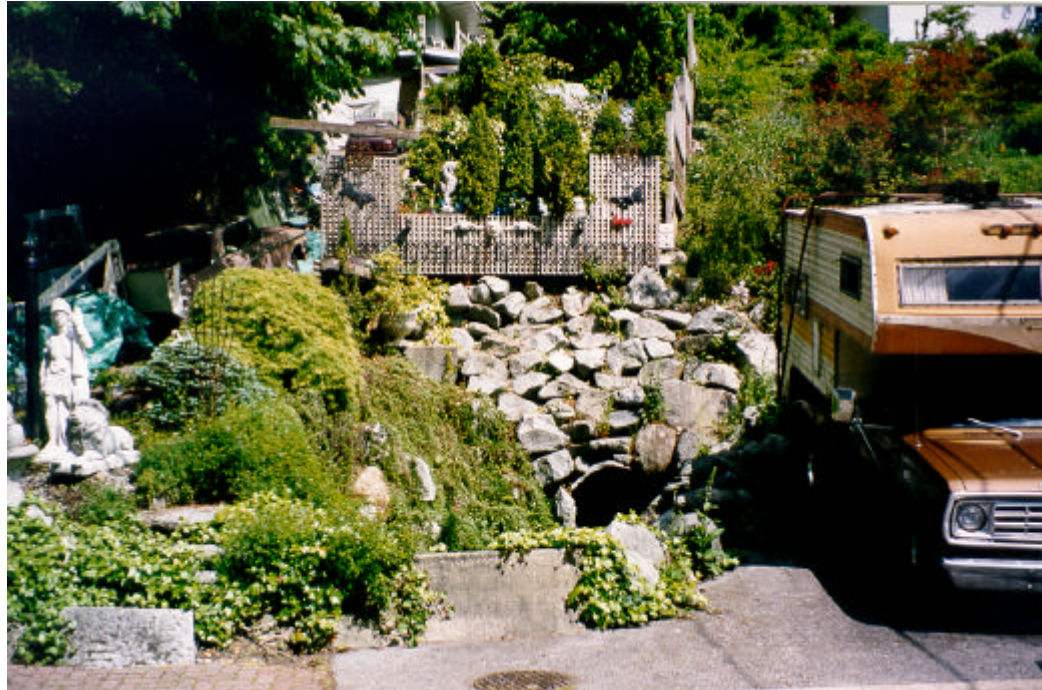
Photo CL-3

Upstream view of Cleopatra Creek from Panorama Drive. Visible in the background is the 20 m long 1000 mm culvert that runs through the residential property. May 2002.

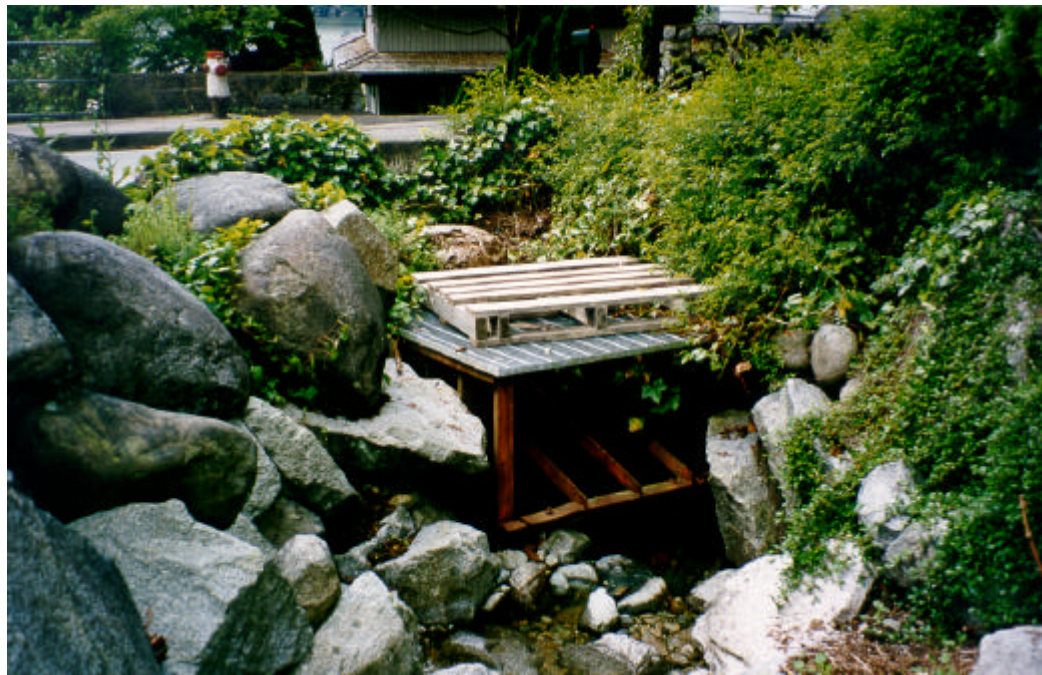
Photo CL-4

Culvert inlet of Cleopatra Creek at Panorama Drive. A 2 m drop leads to the culvert inlet and a steel grate has been placed on top to prevent debris blockage. May 2002.

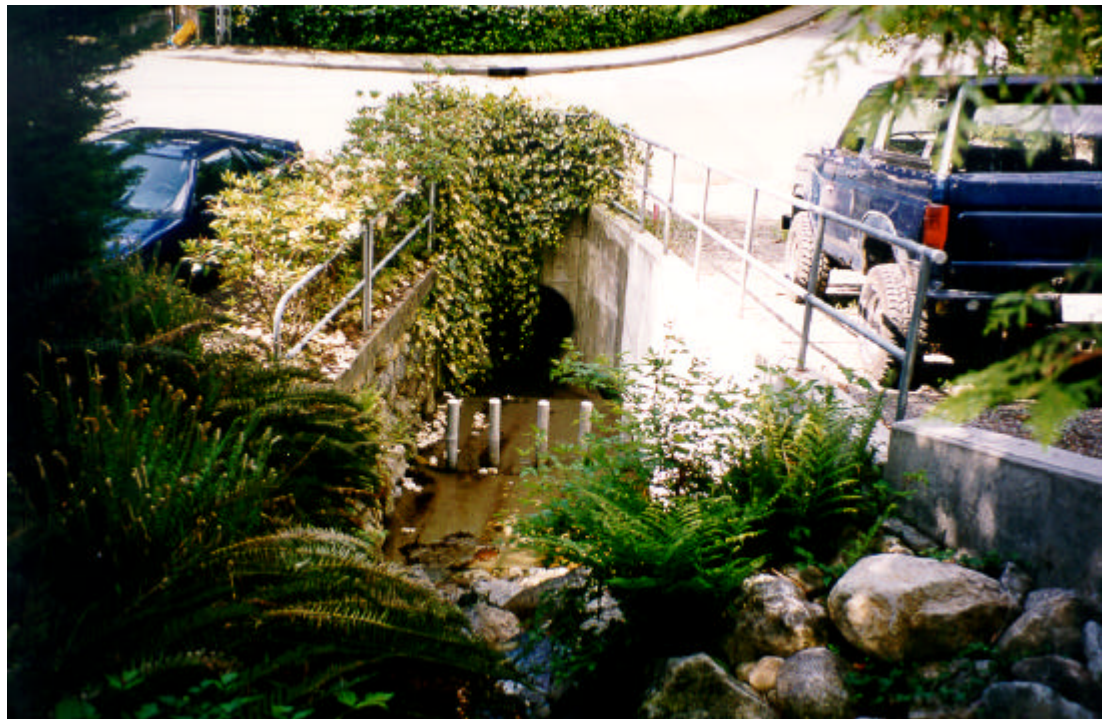
Photo MAR-2
Culvert inlet (1100 mm diameter) of Martin Creek at Panorama Drive. A small debris barrier is visible upstream of the culvert entrance. May 2002.

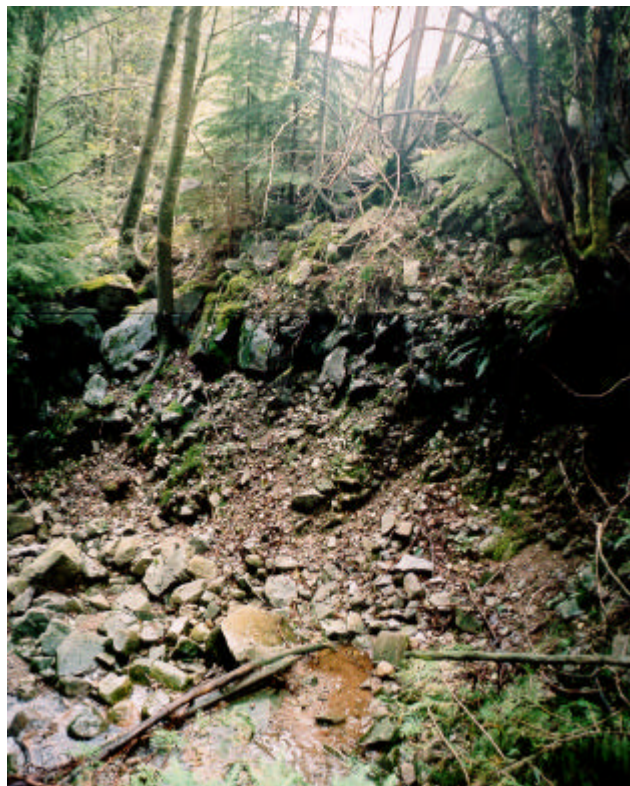
Photo F-2
Bank erosion of fill slope at the
first switchback of Mount
Seymour Road. Approximate
elevation 390 m. October 2001.

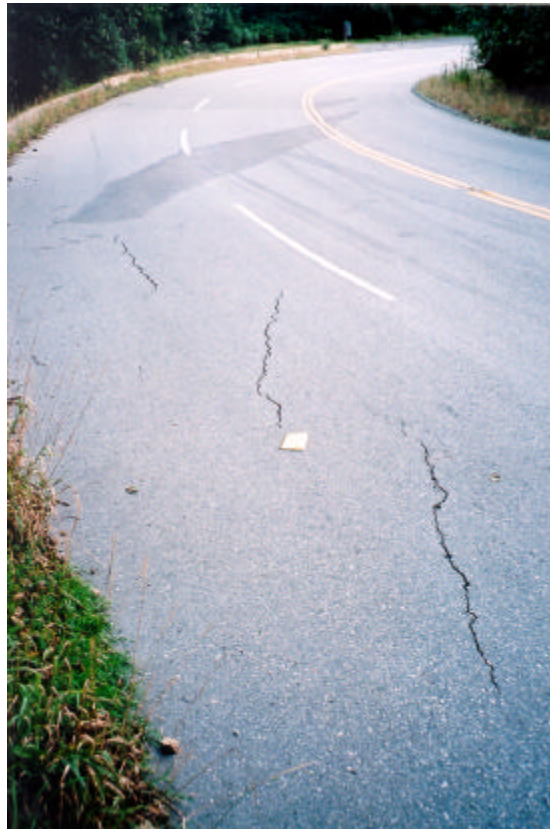
Photo F-3

Tension cracks on the surface of Mount Seymour Road at the lowermost switchback. Further erosion of the fill slope by Francis Creek could result in road failure. October 2001.

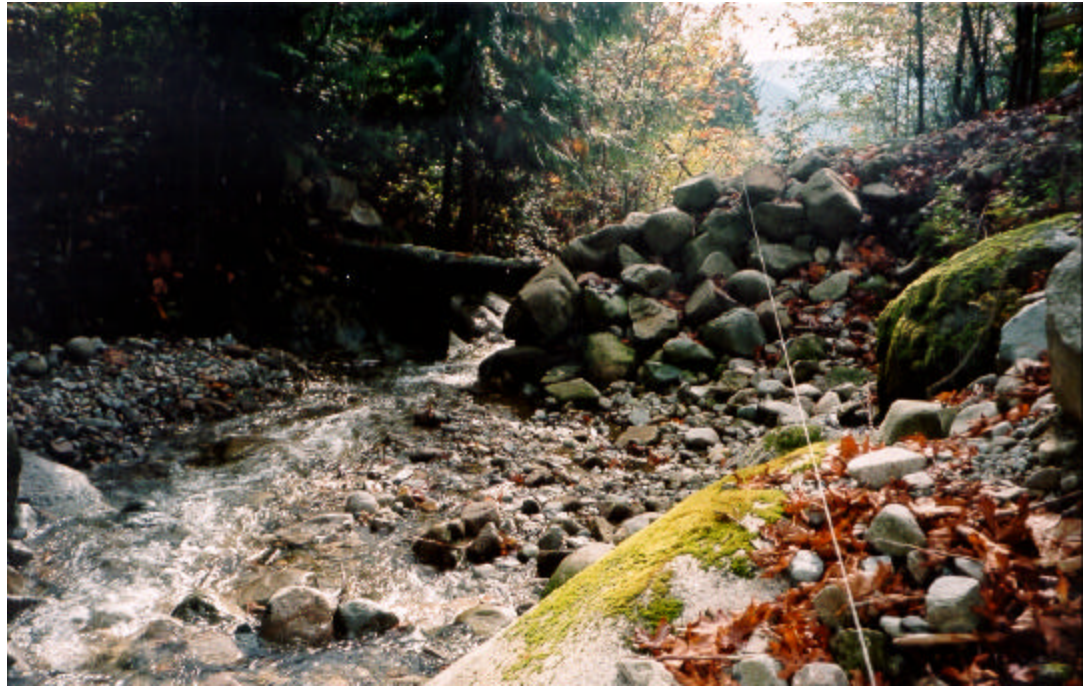
**Photo F-5**

Small concrete dam with box outlet located approximately 200 m upstream of Indian River Drive. A house is located to the right of the riprap. October 2001.

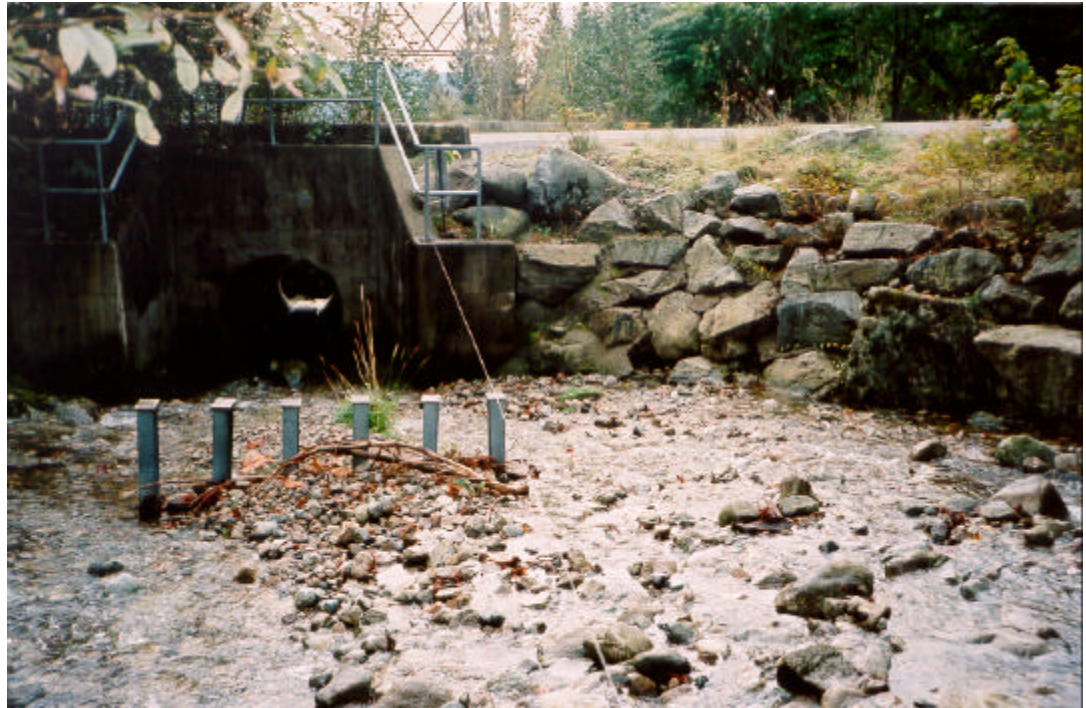
Photo F-7
Debris barrier at culvert inlet of Francis Creek, Indian River Drive. October 2001.

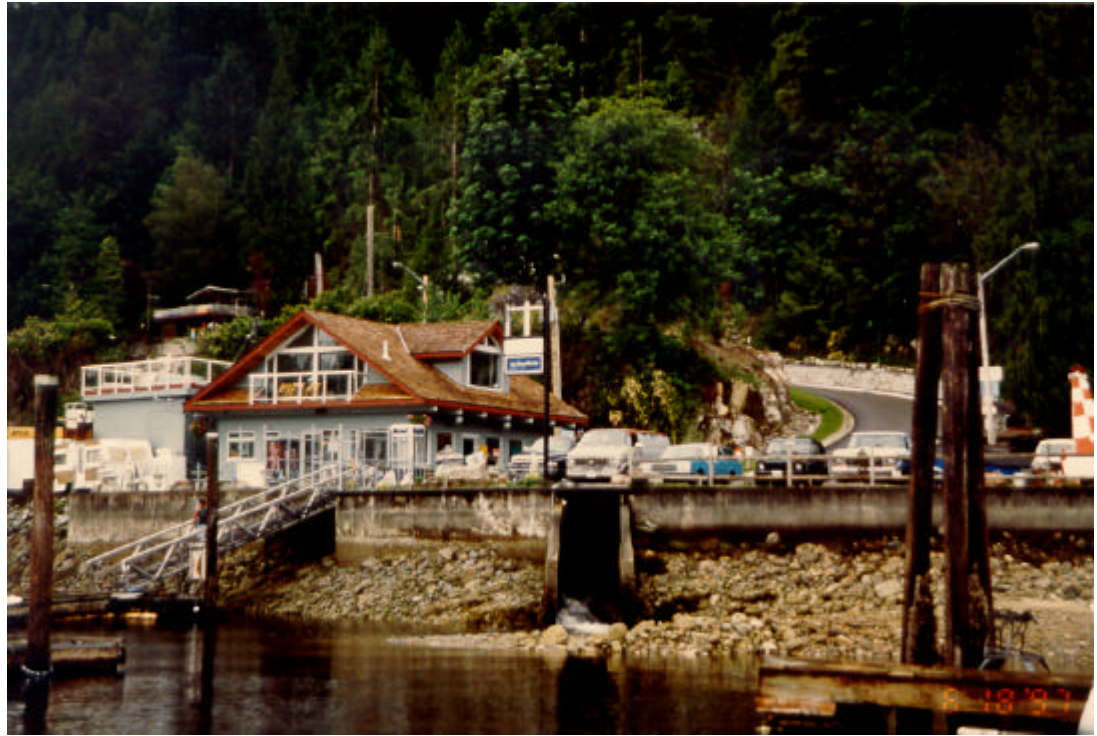
The design debris flow could result in direct impact to the buildings at the Deep Cove Marina. In addition, the parking lot and box culvert could sustain damage (Photo F-11). A debris flow could also result in indirect debris impact to a house located along the creek corridor approximately 200 m above Indian River Drive (Photo F-6). The 1,500 mm culvert at Indian River Drive would be damaged by the design debris flow and the road bed could sustain significant damage.

Photo F-11
Deep Cove Marina and the box culvert outlet for Francis Creek. June 1997.
