# Debris Flow Hazards in the District of North Vancouver

*District of North Vancouver, North Vancouver, B.C.*

**kwl** KERR WOOD LEIDAL  
associates limited  
CONSULTING ENGINEERS

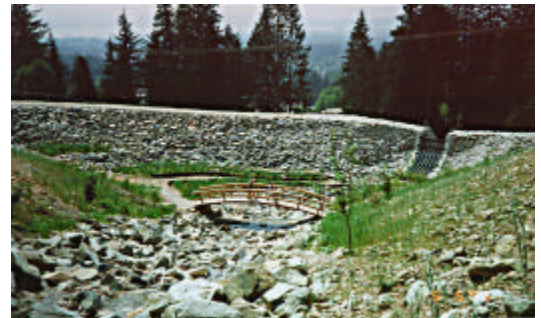
Upper Mackay Creek Debris Basin

Following the 1995 Upper Mackay Creek debris flow, the District initiated a comprehensive debris flow program. The first step involved mitigating the hazard at upper Mackay Creek by restoring the creek channel, completing a detailed creek study, and constructing a 13,000 m<sup>3</sup> debris basin. These works were completed in 1996/97 at a cost of almost \$2 million.

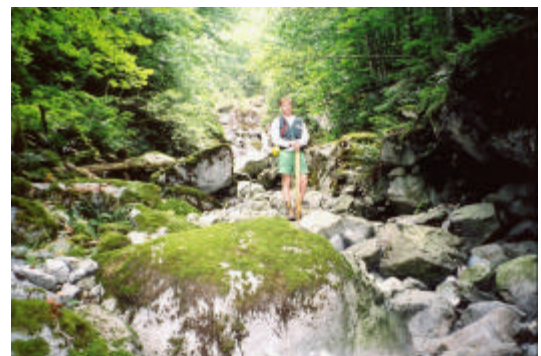
Boulders Transported by Debris Flow

A debris flow is a form of channelized landslide that may occur during unusually wet weather on a steep mountain creek with abundant debris sources. A debris flow can reach a speed of 40 km/h, carry car-sized boulders, and have a volume of many thousand cubic metres. A debris flow may also have a peak discharge that is up to 50 times higher than a peak flood event. Debris flows pose a significant hazard to development located near a creek channel or on a creek fan.

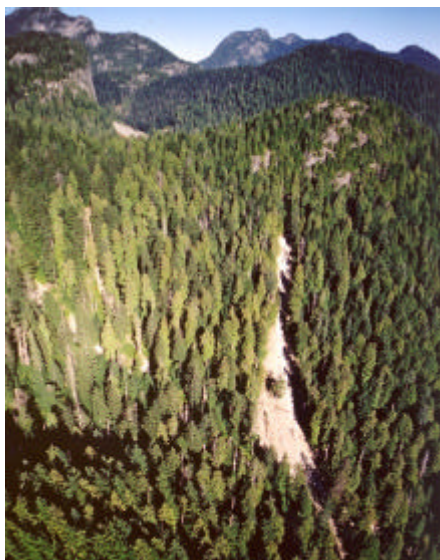
Debris Source Area

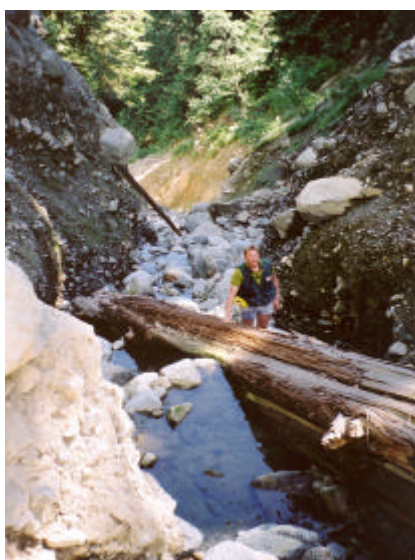
Unstable Channel

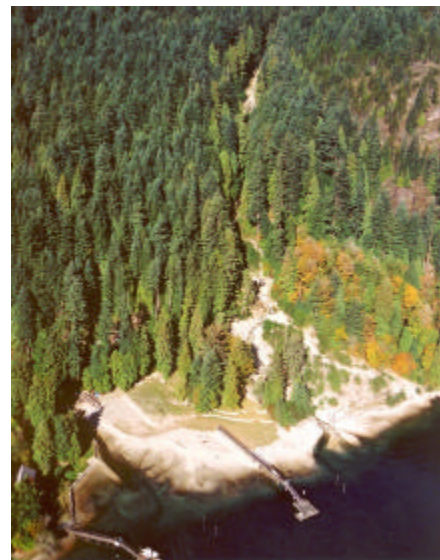
Creek Fan
