## **DISTRICT OF NORTH VANCOUVER**

# **1576 AND 1582 MERLYNN CRESCENT LANDSLIDE RISK REASSESSMENT**

PROJECT NO.: 0404081

DATE: October 24, 2017

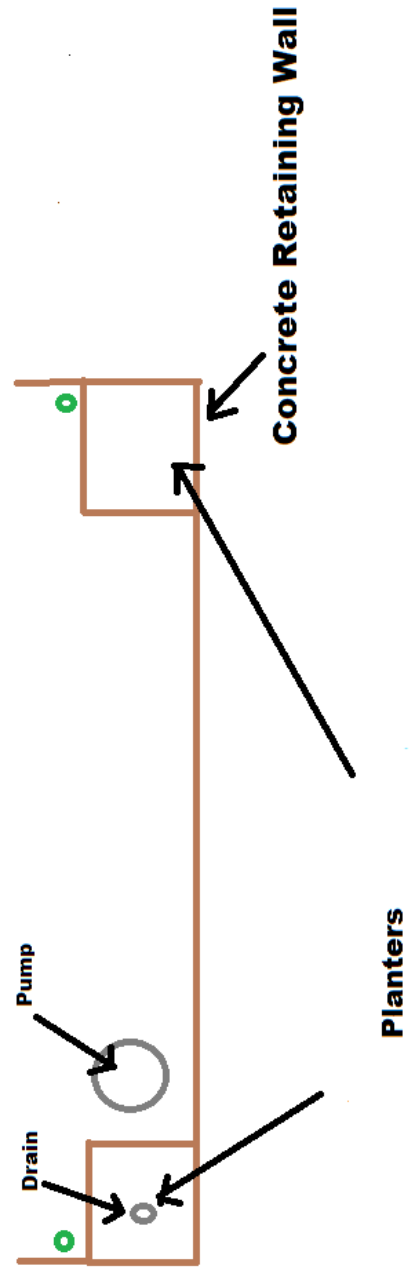
- Drains into ground
- Drains into garden
- PVC pipe

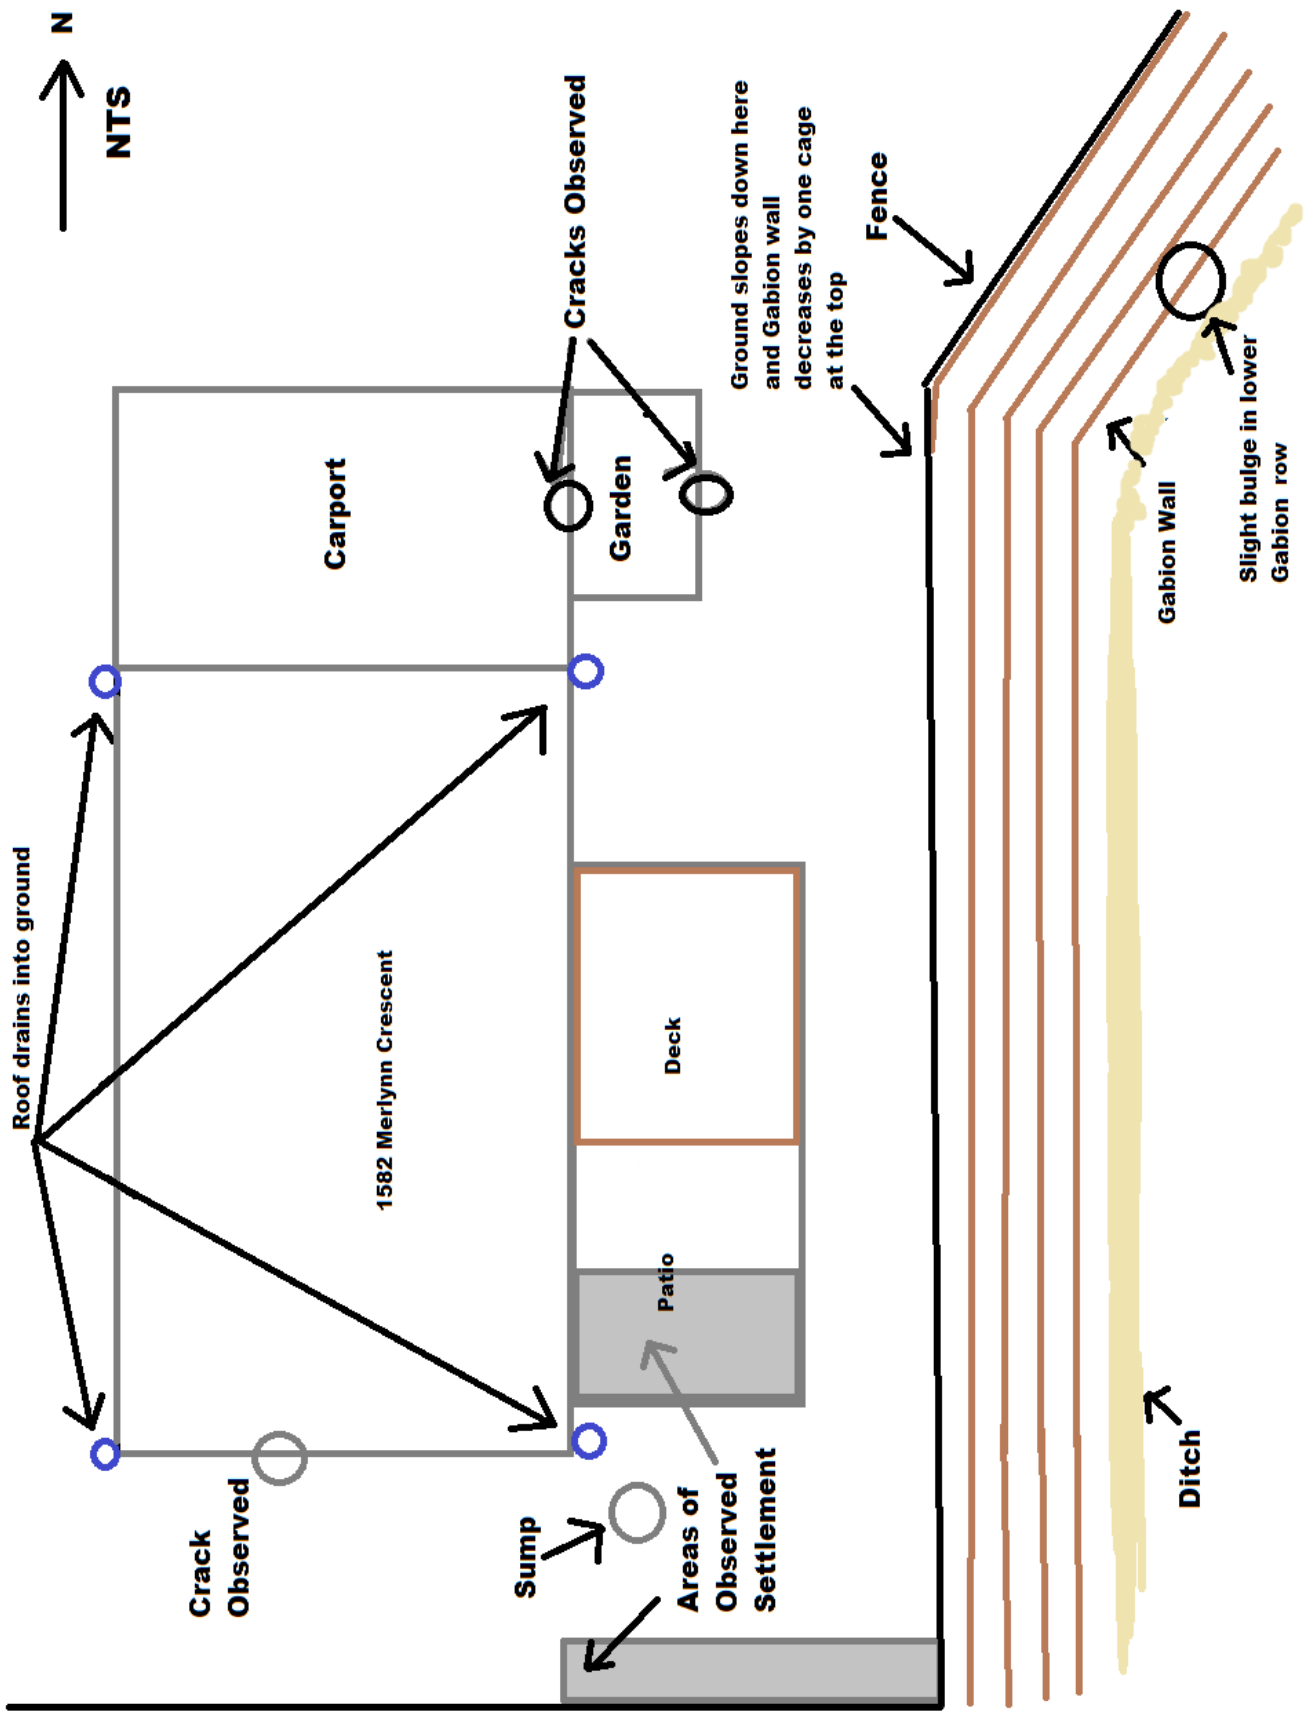
<b>SURFACE RUNOFF FROM:</b>	<b>BACKYARD</b>	<b>½ ROOF</b>	<b>FULL ROOF</b>	<b>FRONT YARD</b>	<b>STREET</b>
				<b>X</b>	
<b>OBSERVATIONS:</b> Road curb at the crest of the driveway is 4 cm high.

<b>GENERAL OBSERVATIONS:</b>
Some yard waste (felled trees) located on the slope. No drains were located on the slope. The deck posts located approximately 3.5 m from the house are straight. Some cracks were noted in the carport foundation and garden retaining wall. The cages of the MSE wall on the north side were filled with clean granite cobbles, while the gabion cages on the south side of the wall included more fines and organics on top of and inside the cages. A small, approximately 0.5 m wide ditch is located downslope of the retaining wall. Perimeter drains and downspouts appear to go to the front yard. Crack noted on the south side of the home.
