District of North Vancouver

Debris Flow - Debris Flood Study and Risk Mitigation Alternatives for Deep Cove Creeks

**Final Report
December 2003**

KWL File No. 31.290

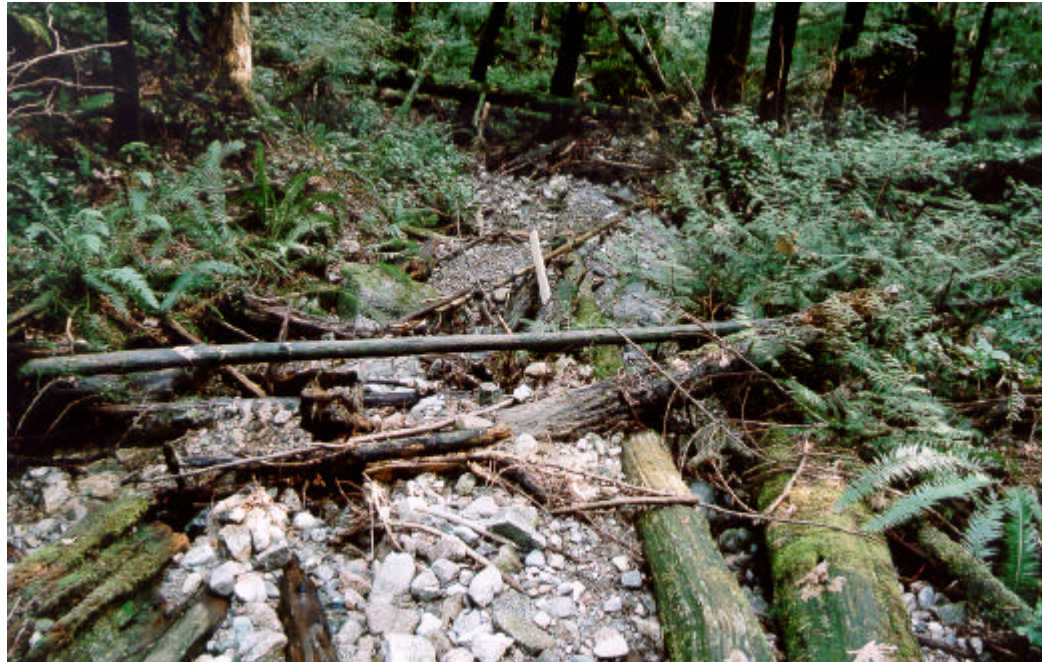
Photo G-1

Downstream view of Gavles Creek from Baden-Powell Trail (crossing upstream of Indian River Drive). March 2001.

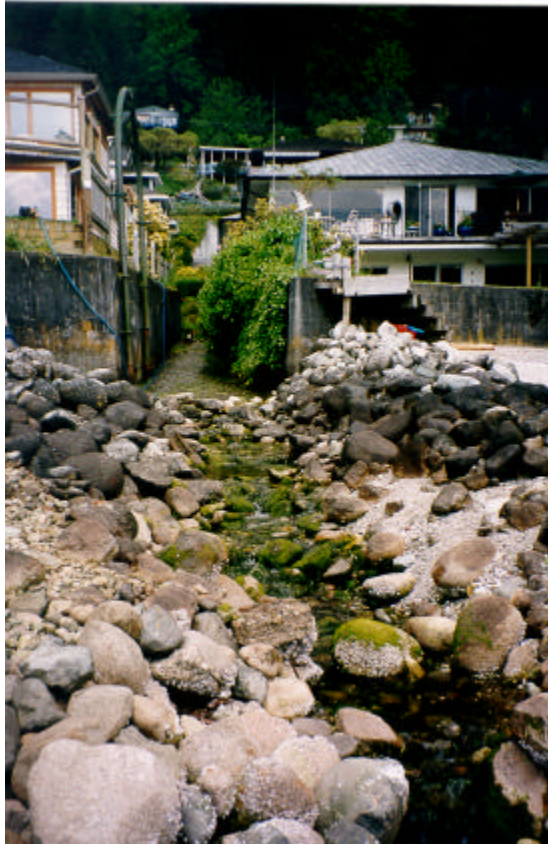
Photo C-5

Upstream view of concrete channel that both Cove Creek and Cleopatra Creek discharge into below Panorama Drive. May 2002.

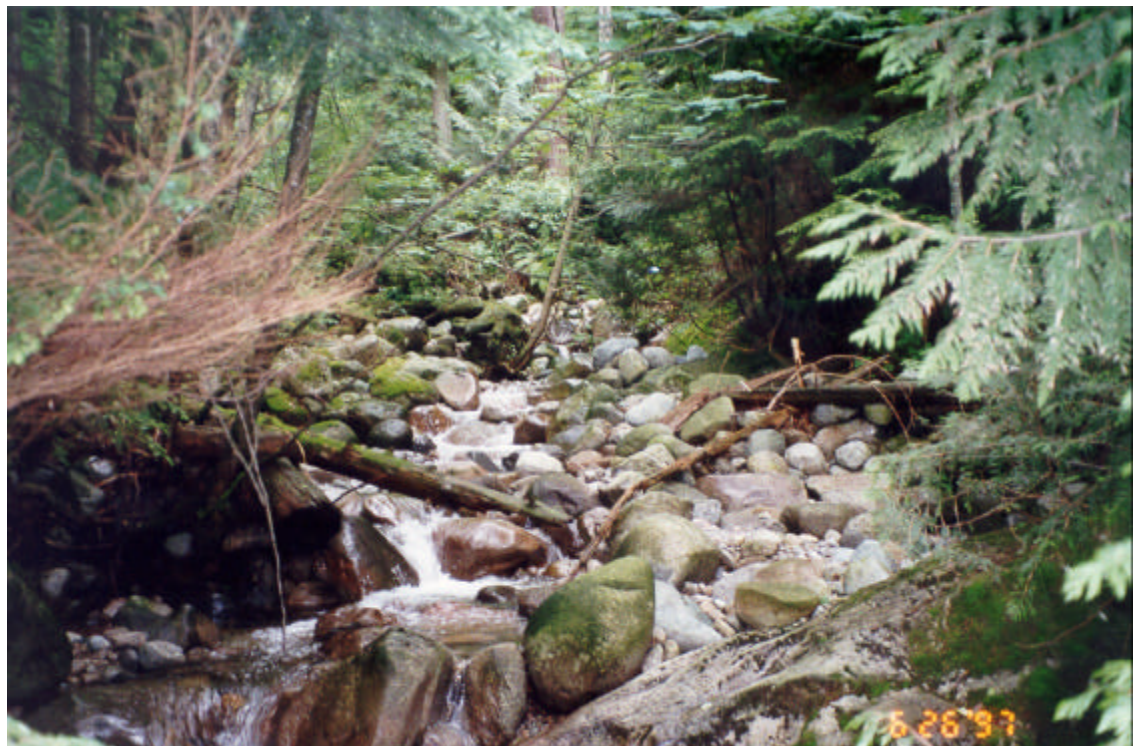
Photo F-4

Low gradient section of Francis Creek at about 320 m elevation. June 1997.

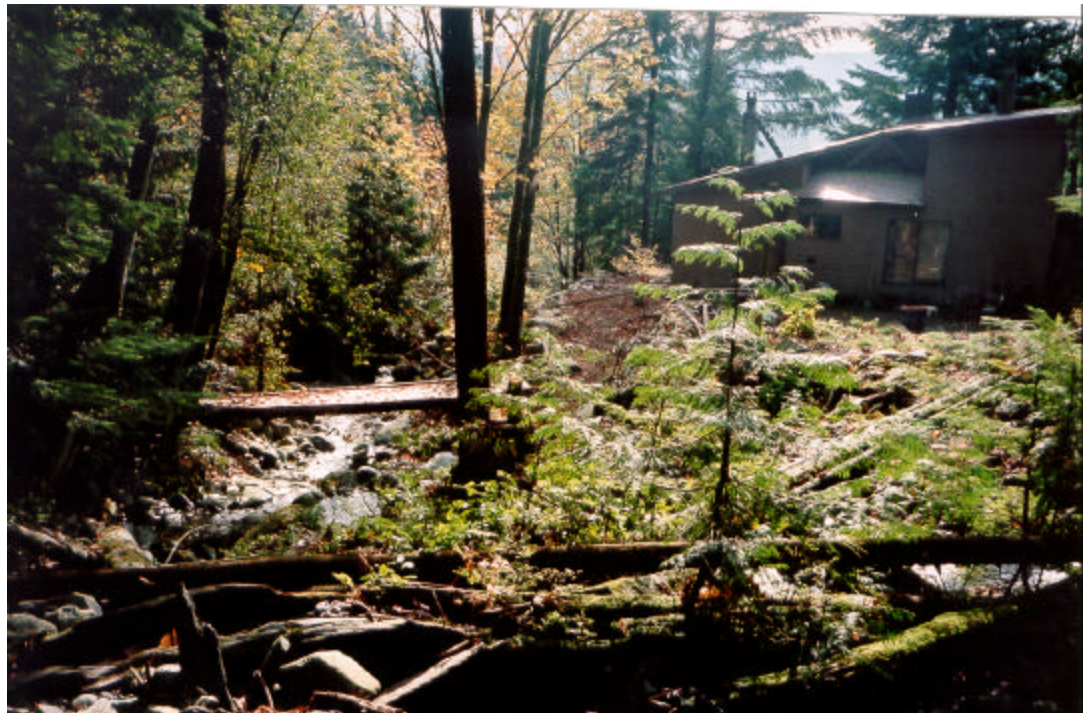
**Photo F-6**

Residential house located approximately 200 m upstream of Indian River Drive. Approximate elevation 225 m. October 2001.
